EZ Hauler Fiberglass Boom Adhesive Test Procedure – Must be Performed Annually

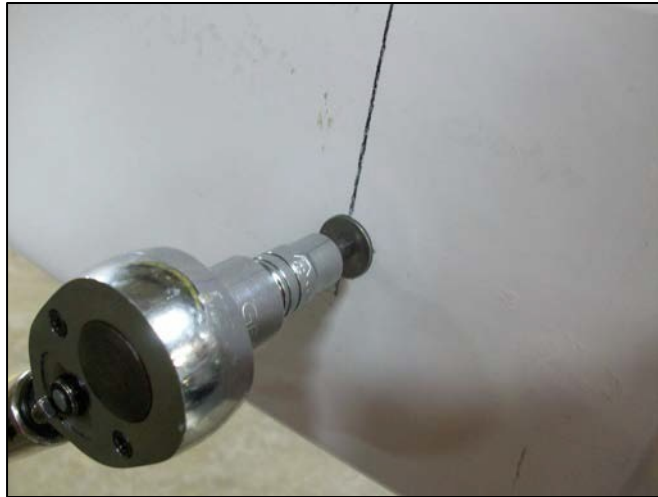
Fig. 1

1. Locate the two screws, one on each side near the outer end of the fiberglass stinger. Observe the area for any damage to the fiberglass and record the information. Remove both screws. *(See fig. 1 & fig. 11)*

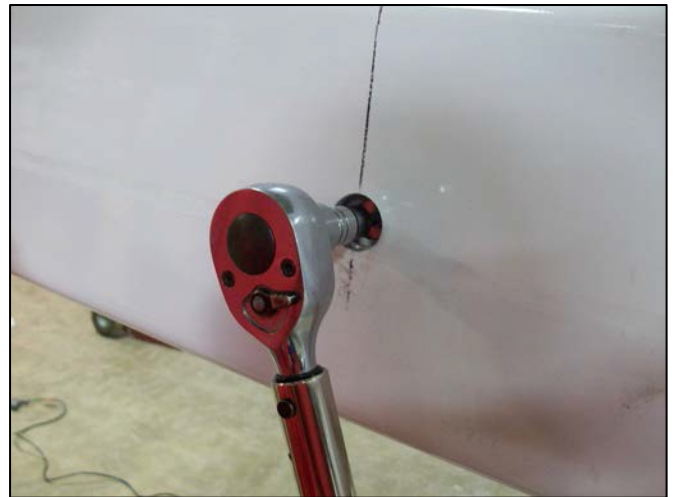
Fig. 2

2. Locate the two screws, one on each side at the inner end of the fiberglass stinger. Observe the area for any damage to the fiberglass and record this information. These screws will be visible through an inspection hole in the 2nd extension. The inspection hole is approximately 11" from the end on model 5500, or 35" from the end on model 3000. Remove both screws. *(See fig. 2 & fig. 11)*

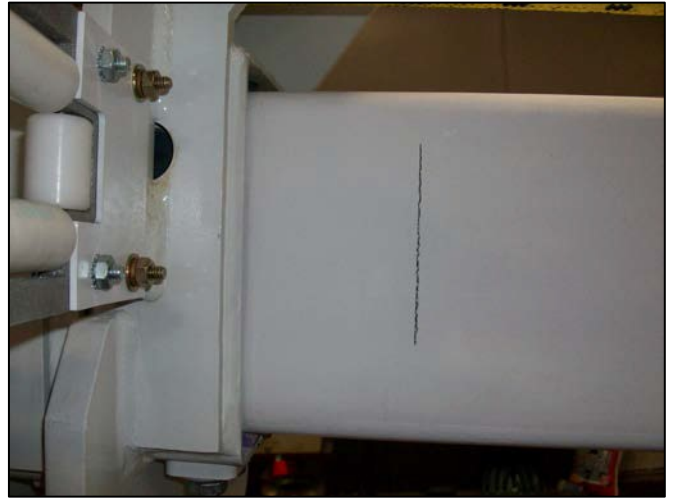
Fig. 8

8. Again, fully extend the last/stinger boom. Remove the stop/test block. Observe the line drawn in step 2. It should align with the end of the 2nd extension boom as marked in step 2. *(See fig. 7)* **If the line on the boom is no longer aligned as drawn (See fig. 8), the fiberglass boom must be replaced.** If the line is as originally marked, proceed to the next step. If uncertain if movement has occurred, repeat steps 6 through 8.

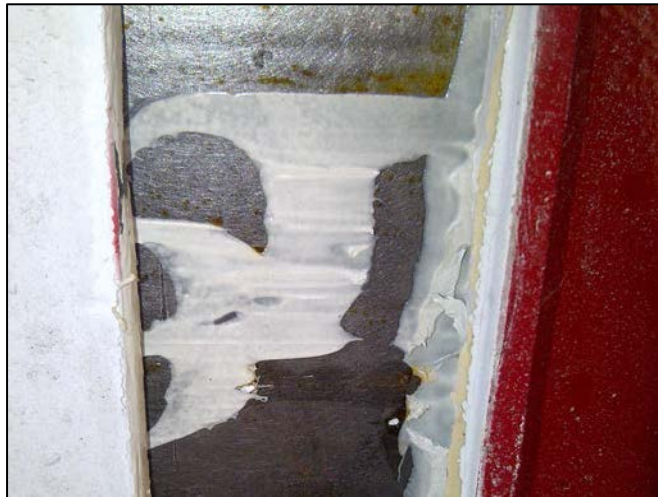
Fig. 9

9. Observe the end of the last/stinger boom outer end of the fiberglass. **If the insert here has pulled out (See fig. 9), the fiberglass boom must be replaced.** If it is as originally assembled, proceed to the next steps.
