EZ Hauler Fiberglass Boom Adhesive Test Procedure – Must be Performed Annually

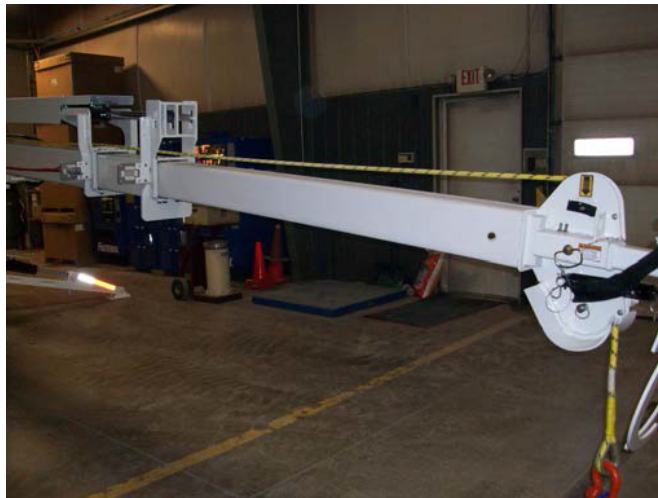
Fig. 3

4. Extend the last/stinger extension boom fully. *(See fig. 3)*
5. Using the wax (china) marker, draw a line on the fiberglass boom along the end of the 2nd extension boom. *(See fig. 4)*

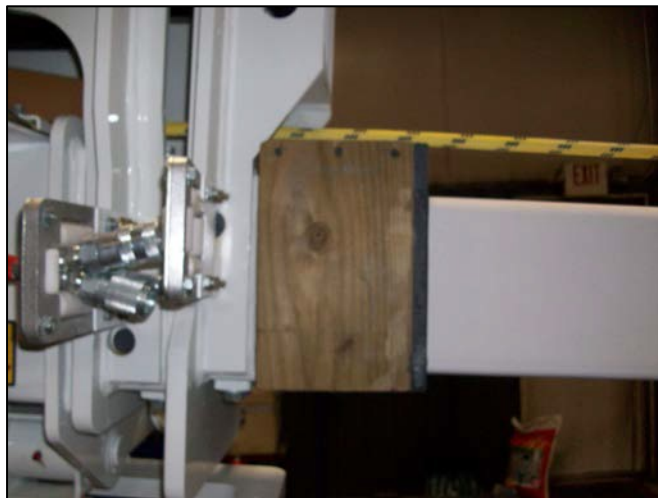
Fig. 5

6. Place the stop/test block over the fiberglass portion of the last/stinger boom. *(See fig. 5)*
7. Using the controls for the crane, retract the last/stinger boom fully until the hydraulics dead-head against the stop/test block. *(See fig. 6)* Release the pressure against the test block and repeat the dead-head and release process four additional times.

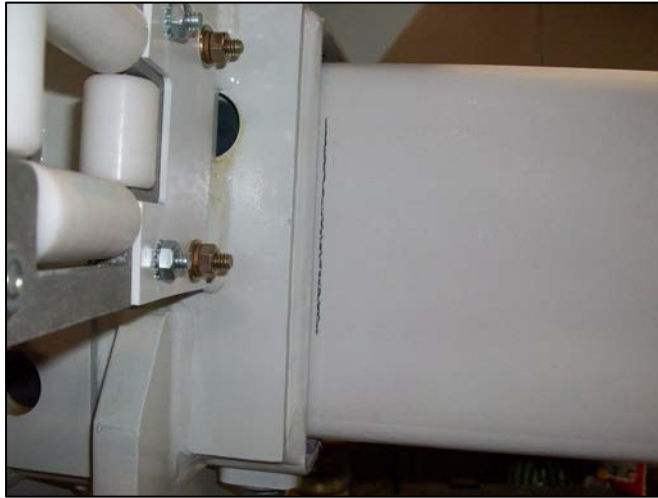
Fig. 7

8. Again, fully extend the last/stinger boom. Remove the stop/test block. Observe the line drawn in step 2. It should align with the end of the 2nd extension boom as marked in step 2. *(See fig. 7)* **If the line on the boom is no longer aligned as drawn (See fig. 8), the fiberglass boom must be replaced.** If the line is as originally marked, proceed to the next step. If uncertain if movement has occurred, repeat steps 6 through 8.
